ANNAN MOTTE AND BAILEY AUDIT

MAY 2006

Bruce's Motte and Bailey is one of a linked programme of 21 diverse projects that are being developed in the Sulwath Connection Landscape Project. This document is part of the development stage of the Sulwath Connection Landscape Project that will provide a design and programme of work to be submitted to Historic Scotland and Dumfries and Galloway Council for approval.

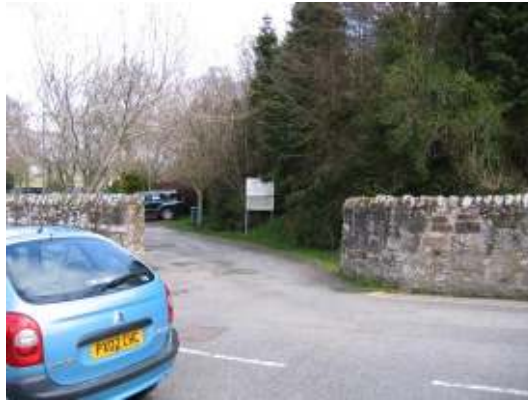
The Motte and Bailey is, despite its size, largely hidden from view except when approaching Annan from the West. The earthworks can be seen on the opposite bank of the river although it is largely obscured by trees in the summer. The approach to the site from the Town Centre is down Bruce Street or Battery Street although there are no signs to indicate the location of the historic site. A combination of high stone walls and vegetation obscures the nature of the site even when it is very close. The approach roads are narrow and lack footways near the entrance to the car park and at the East (Bruce Street) entrance.

- 1 Thin Embankment vegetation to open up views into the historic monument.
- 2 Signpost the Motte and Bailey from town centre to direct visitors to this hidden feature.

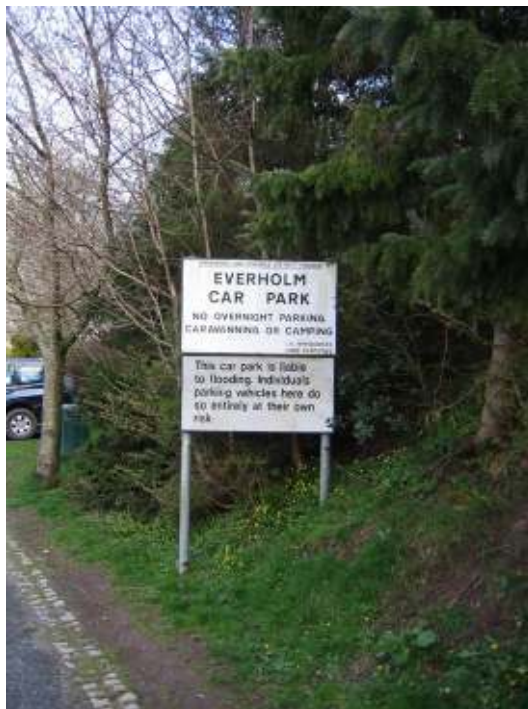
Everholm car park is located immediately to the west of the Motte and Bailey with 40 parking bays. There are no spaces dedicated for disabled visitors. The car park is surfaced with black top and the parking spaces are defined with granite setts. The car park has no parking restrictions and it is therefore popular with workers in the nearby Council Offices. A consequence of this is that there are often no spaces for visitors. The opportunity for kerbside parking is limited in the immediate vicinity of the site due to the narrow carriageways. There are no directional signs from the car park to the Motte and Bailey. A slab footpath leads to the sports centre between the play area and the Motte. A rutted track links the car park to the North Entrance. The car park suffers from occasional flooding when the river is in spate.

The existing car park is well located for visitors to the Motte and Bailey. It has a reasonable standard in layout and demarcation. The absence of dedicated disabled spaces and general lack of available spaces during office hours may need to be addressed. Well designed directional signs are required and a surfaced route from the car park to the north entrance would improve access for many users.

- 3 Consider short stay parking restrictions and identifying disabled parking spaces.
- 4 Provide an entrance sign to the car park which includes 'Motte and Bailey'.
- 5 Provide a surfaced path between the car park and the north entrance.

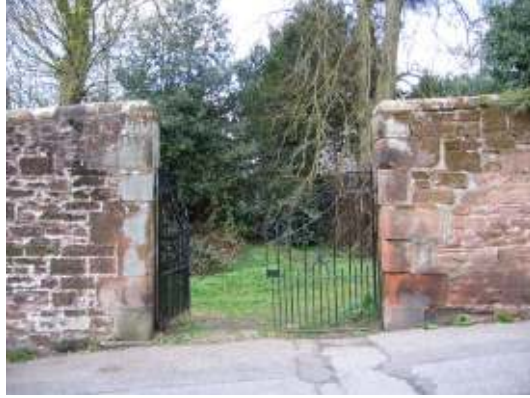
East Entrance

A double metal gate set in the 2.0 m high red sandstone boundary wall on Bruce Street. This has been the main access to the Motte and Bailey for over 150 years and remains the most visible entrance to the historic monument.

All three of the present entrances are not welcoming and appear to keep people out rather than inviting them in. There is no indication of what lies beyond the entrances and sight lines are obscured by vegetation and landform.

- 6 Cut back vegetation to improve views into site, repair gates and erect entrance sign at East Entrance.
- 7 Provide directional signs to North Entrance from car park.
- 8 Monitor use of the South Entrance after vegetation has been cut back to opened up views.

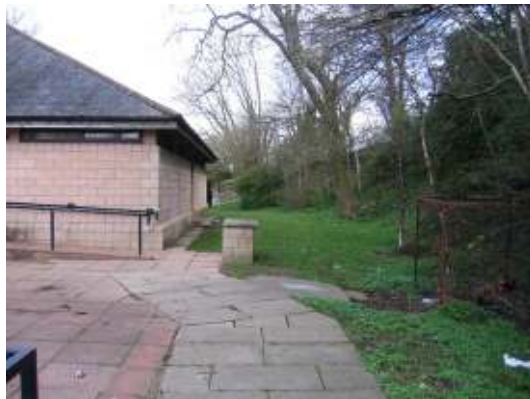
North Entrance

This is a broad rising path at the northern extremity of the site. Hidden behind the sports hall it is also obscured by privet hedging and trees. There is no surfaced path or directional signs between the car park and this entrance.

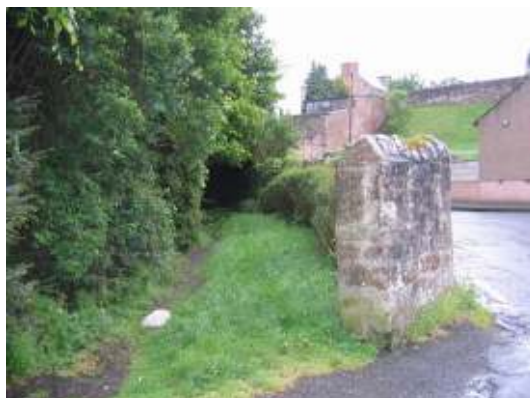
South Entrance

Adjacent to the car park entrance there is a narrow path immediately behind the boundary wall. The path entrance is overgrown with shrubs and enclosed by the high wall on one side and the steep embankment of the Bailey on the other.

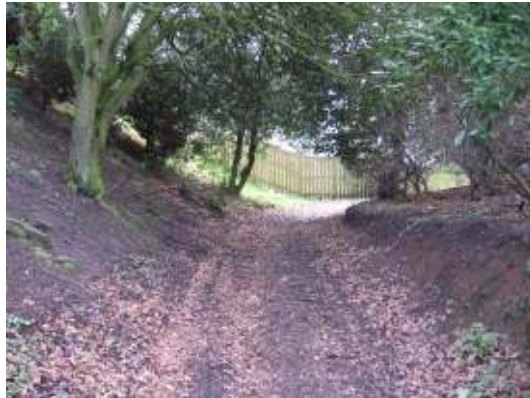
Garden drive

This path starts at the gated East Entrance and follows the base of the eastern slope of the Motte down to the North Entrance. Approximately 2.0m wide it appears to have been a drive linking the out houses to Bruce Street. There is evidence that the drive once had a cobbled surface although most of these appear to be lost. The northern end of the path has a gradient of greater than 1 in 12. Present surface has a layer of soil/leaf litter which will need to be cleared before assessing condition of the harder underlying surface.

9 Re surface existing paths between the East and North entrance and a loop onto the Bailey. The work will include scraping the path to expose the stable ground below and building up with crushed stone, blinded with stone dust and compacted to form a firm surface. Black top surfacing to the track between the car park and north entrance will reduce maintenance implications caused by occasional flooding of this area.

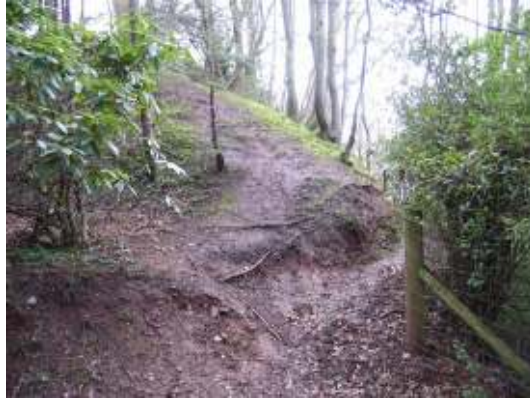
West Path

This narrow beaten earth path of less than 1.0m wide has been cut into the western slope of the Motte above the fence line. There have been problems of erosion where some of the slope has slipped and two retaining structures have been constructed to prevent further erosion. A stone wall is located above the path and the other below the path using scaffolding poles and timber sleepers. Erosion appears to be a continuing problem and is partly due to children playing on the retaining structure that is located above the adjacent play area.

11 Monitor erosion on the Motte embankments and repair where possible.

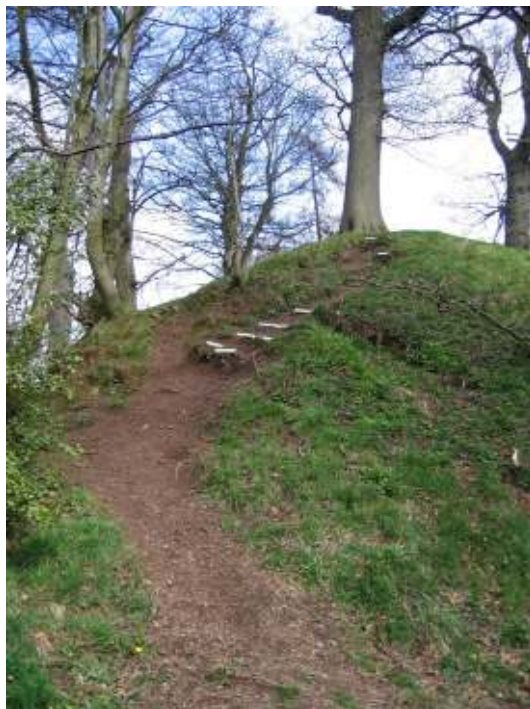
Motte Path

A worn beaten earth route follows a ridge up the south side of the Motte to the highest part of the historic monument. White ceramic glazed garden edging has been used to form steps in the past although most are now missing and an alternative desire line avoiding the old steps is also used.

Observation of the condition of the desired 0 line path to the top of the Motte is particularly important so that the path can be managed to reduce further erosion.

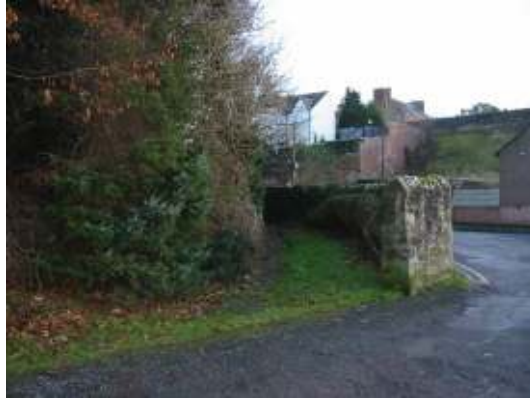
South Path

This narrow path is partly surfaced with blacktop but also has areas of short grass. It follows the boundary wall between the south entrance at the car park to the east entrance at Bruce Street. There is a locked and damaged pedestrian gateway in the wall at the junction of Battery Street and Bruce Street. The section between the car park and gateway has a gentle slope, however it also has a section of path that has a gradient greater than 1 in 12.

The metal gates are to be repaired at both the east entrance and off the south path.

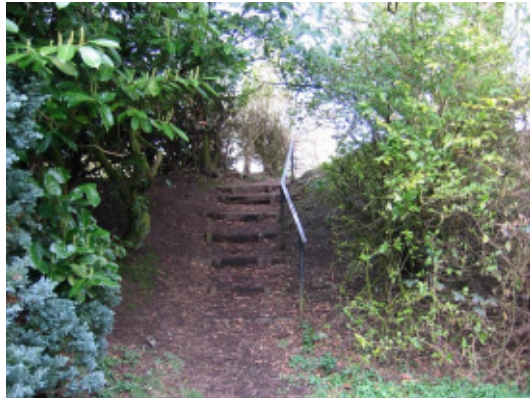
Bailey Paths

There is a circular route that provides access onto the Bailey. From the East Entrance seven ramped steps with timber risers and a metal handrail lead up to the Bailey and a path that continues on the eastern side of the Bailey to link with the south side of the Motte. Dog fouling appears to be a problem on the Bailey area where the grass is regularly cut. There are a number of concrete plinths on the Bailey area which appear to be the remnants of seats or play equipment.

10 Rebuild the seven steps at the Bailey including the handrail.

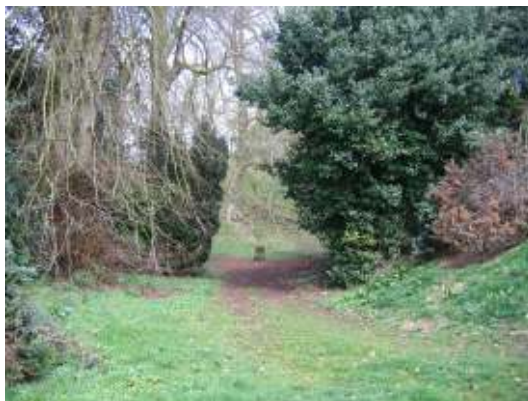
There is no interpretation on site to indicate the presence of the monument although a stone plinth located between the Motte and the Bailey once had a cast metal plaque fixed to the top. The Motte and Bailey does appear in some leaflets including ‘Archaeosights – Follow the Bruces and Balliols’.

The stone plinth was built as part of the ‘Archaeosights’ trail and a plaque described the tale of the curse of St Malachy. The plaque was heavily vandalised before being eventually removed. The vandalism was believed to have been partly due to the lack of visibility from passers by who would have provided a certain degree of ‘community policing’. There are opportunities to add interpretation both on the site and at nearby approaches which relate to other Sulwath Connection projects.

12 Remove stone plinth.

13 Install an interpretation panel or feature within the site near the east entrance.
