ANNAN MOTTE AND BAILEY AUDIT

MAY 2006

Bruce's Motte and Bailey is one of a linked programme of 21 diverse projects that are being developed in the Sulwath Connection Landscape Project. This document is part of the development stage of the Sulwath Connection Landscape Project that will provide a design and programme of work to be submitted to Historic Scotland and Dumfries and Galloway Council for approval.

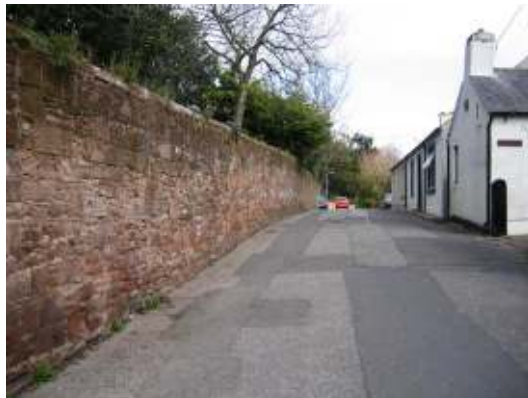
Thinning of vegetation will help make the landform more noticeable. Sign posts from the town centre would make people more aware of the site and direct them to the entrances. The absence of footways is a matter of concern; however the narrow street offers no opportunity to improve the pedestrian environment without further restricting vehicular movement.

- 1 Thin Embankment vegetation to open up views into the historic monument.
- 2 Signpost the Motte and Bailey from town centre to direct visitors to this hidden feature.
